Rail Accident Report

Head-on collision between a passenger train and a freight train
in Tempi, 28 February 2023

RL01-2025, 27 February 2025

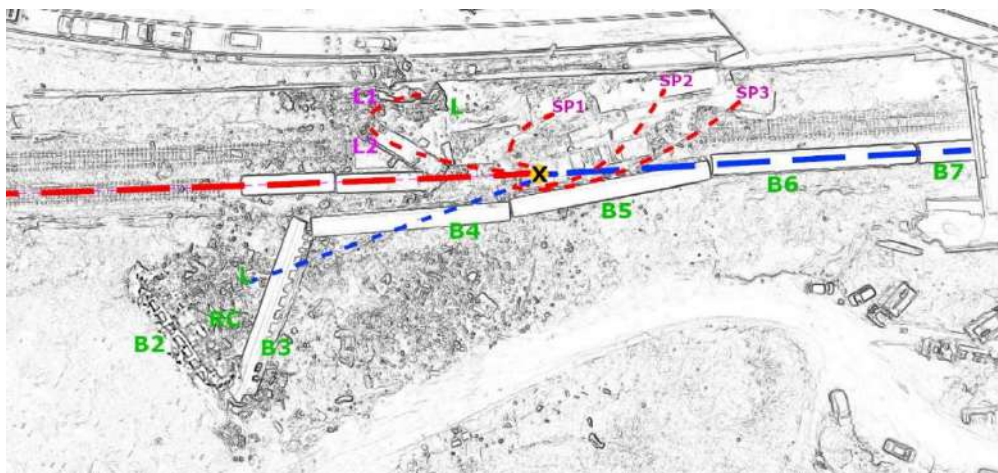
Figure 11. Global movement of the collision, with the initial impact and catapult effects. (SP1,2,3 are Steel Plates, and were also catapulted)

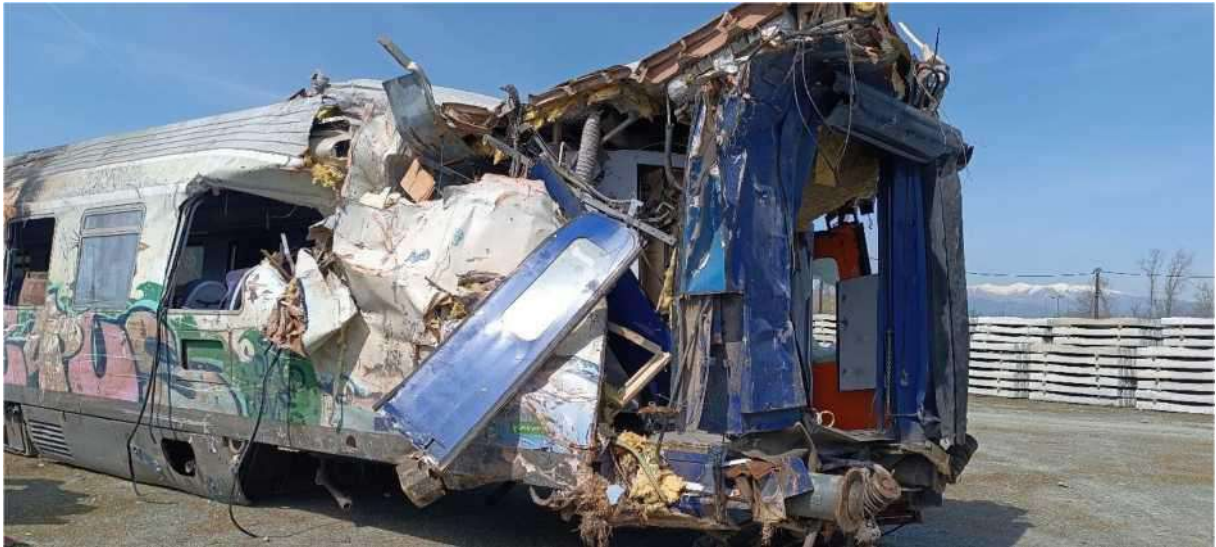
140 Derailed by the collision of the Restaurant Car, the B2 vehicle (a passenger coach divided into 11 6-seat compartments) continues straight ahead with a slight angle to the train tracks, nose diving downwards and hitting the ground with its front end, bending and breaking off its front section in the middle of compartment no 2. After the head-on impact, the rear of the wagon is lifted high and to the left and coming down to hit the front of the B3 passenger coach.

Figure 23. Remains of the B2 coach

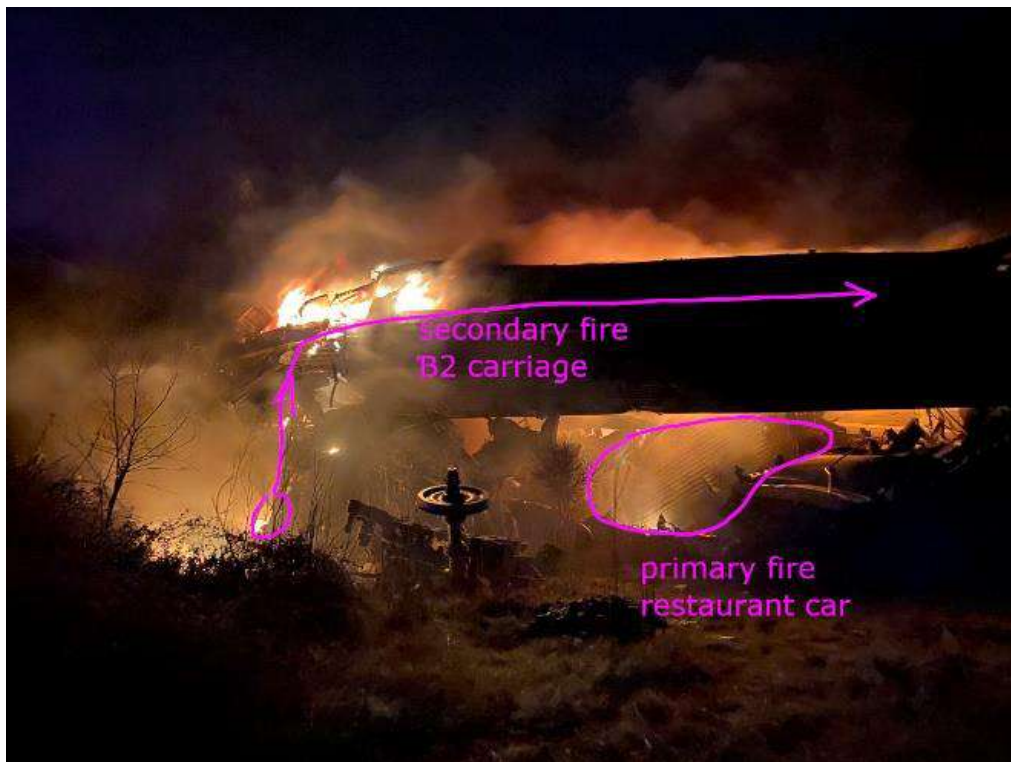
Figure 33. Another fire started at the front of the B2 coach.

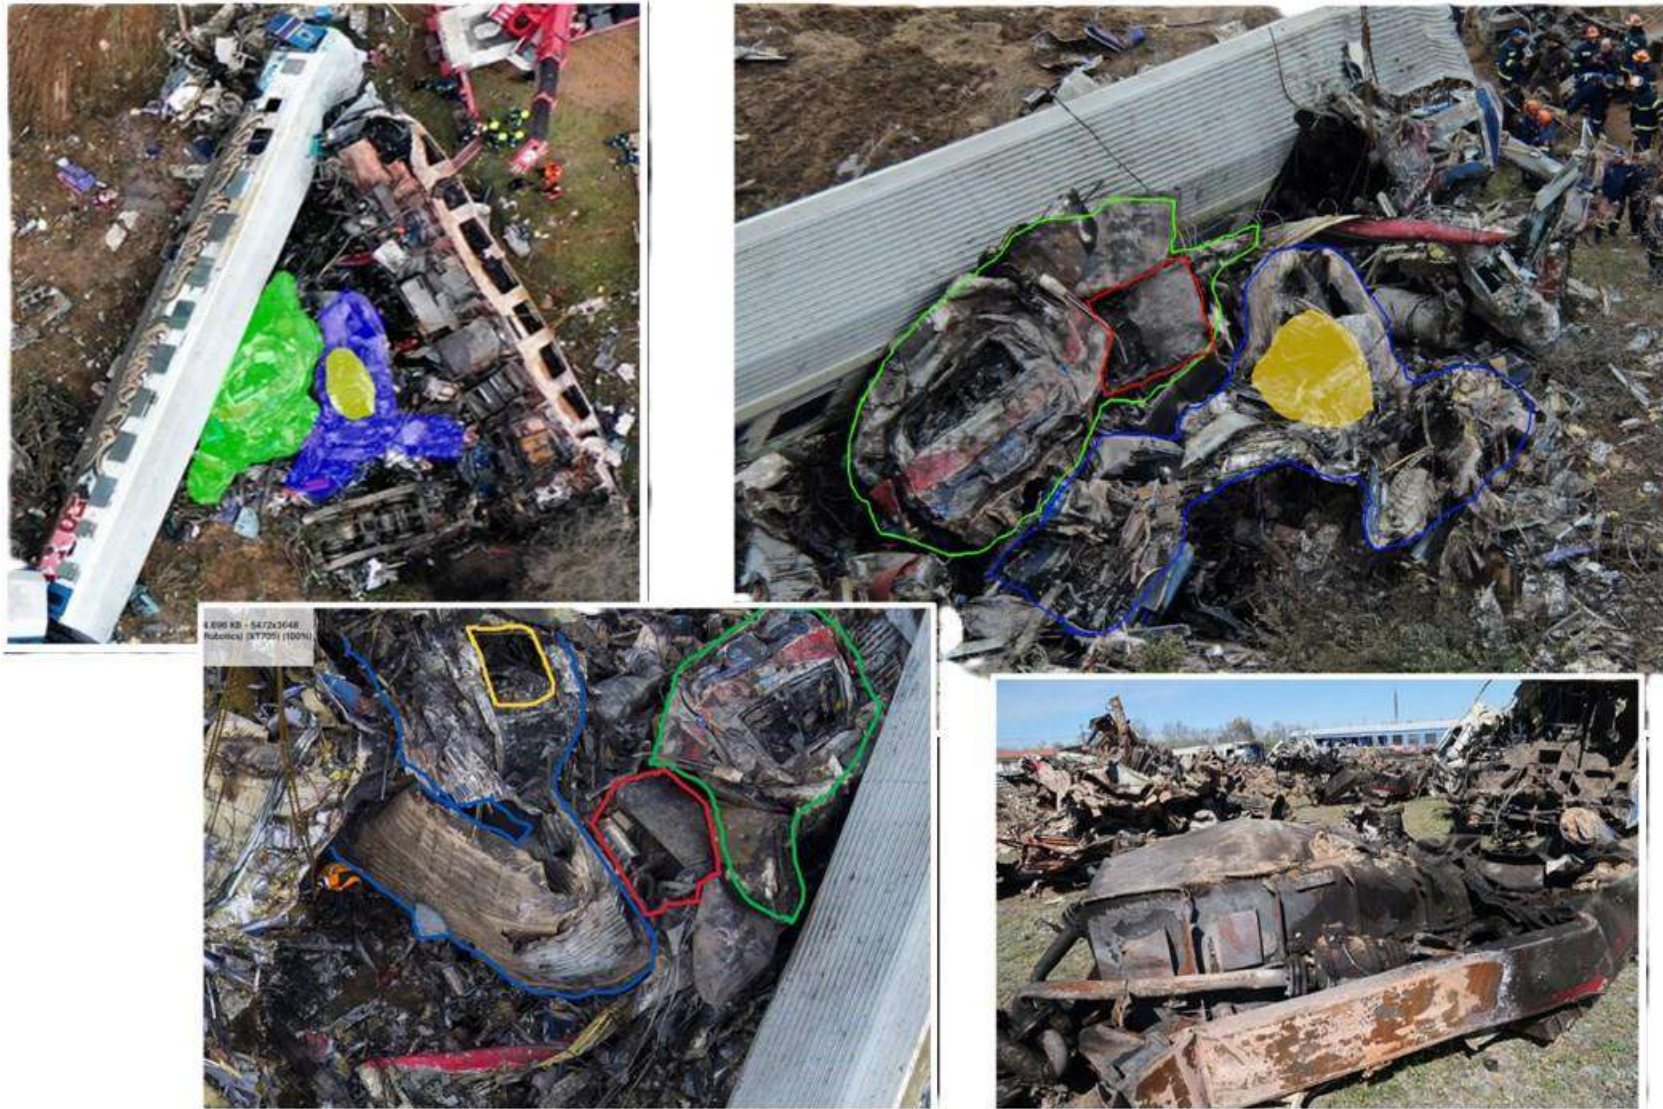
Figure 61. Further images of the location of the Restaurant Car, Passenger Locomotive and its transformer.

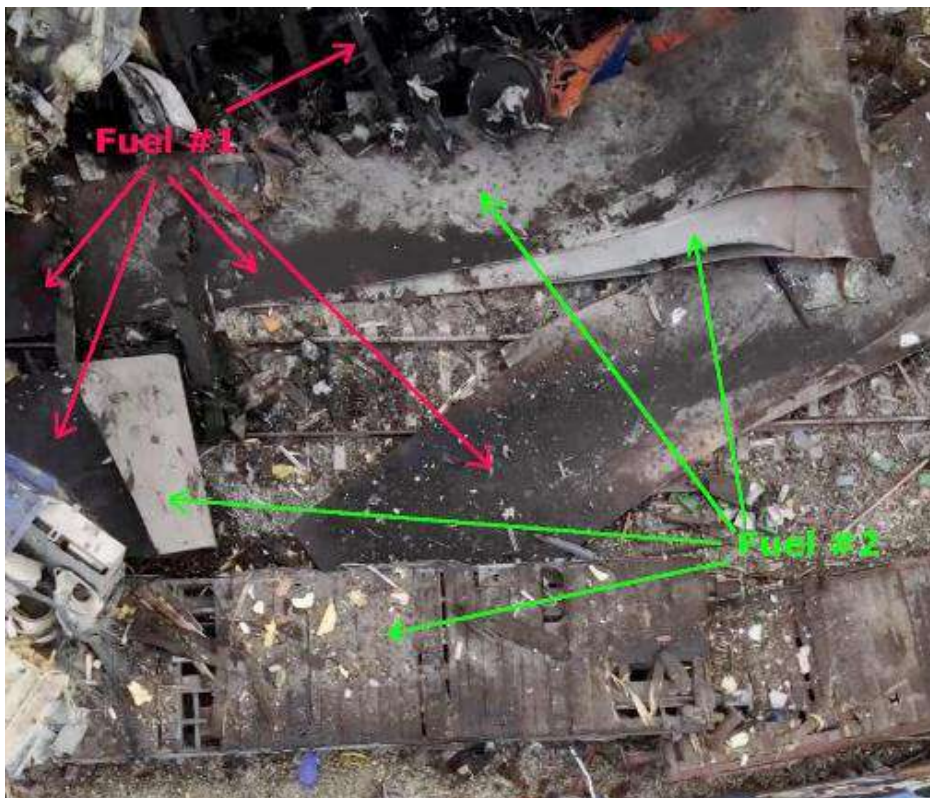
Figure 66. Evidence of two different fuels burning in the pool fire #1, one leaving black, the other leaving white residue.

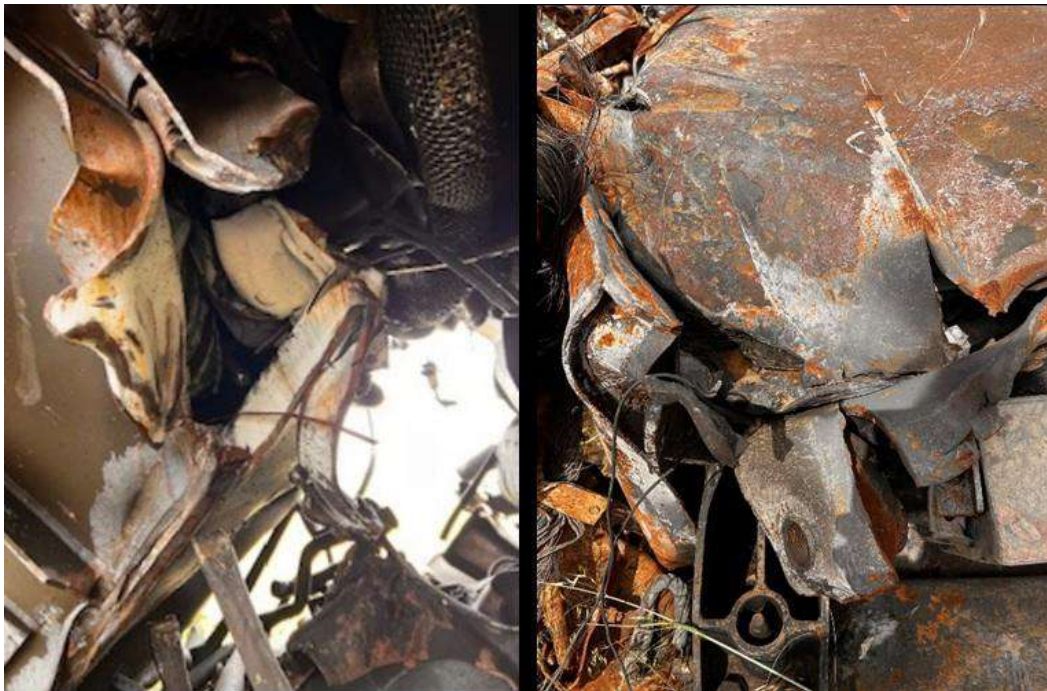
Figure 67. Large cracks of the transformer still attached under the 120-022 locomotive (Left). Bumps, folds, rips and large cracks of remaining locomotive transformer 120-023 (right), see also Figure 61.

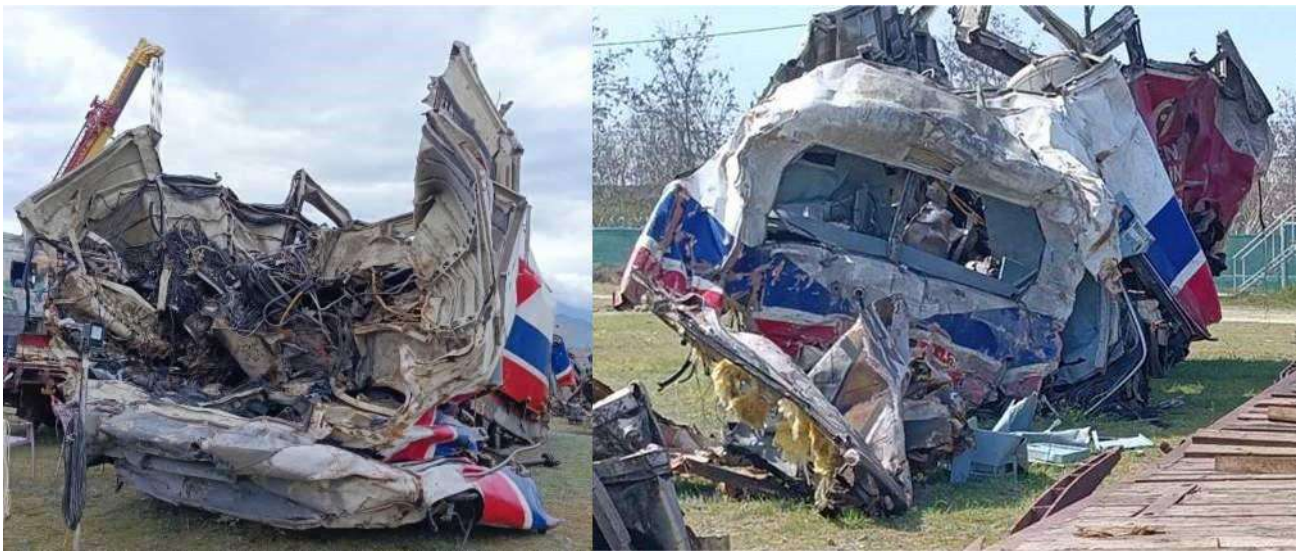
Figure 77. Position 1) Siemens Hellas Sprinter 120-022- NVR Engine: 91 73 212 0 022-7 Extreme damage on the front, roof missing, and rear heavily damaged from the rear collision with the attached locomotive 120-012. Rear view in Figure 14.

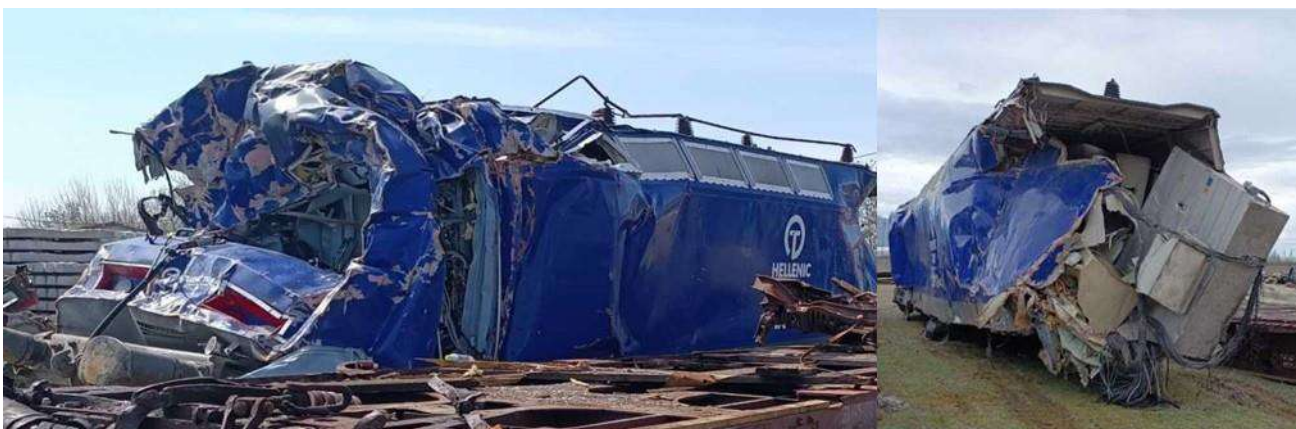
Figure 78. Position 2) 120 012 locomotive, heavy damage in the front (with locomotive 120-022) and rear, signs of crash against 1st container on P4, without the missing rear cab.

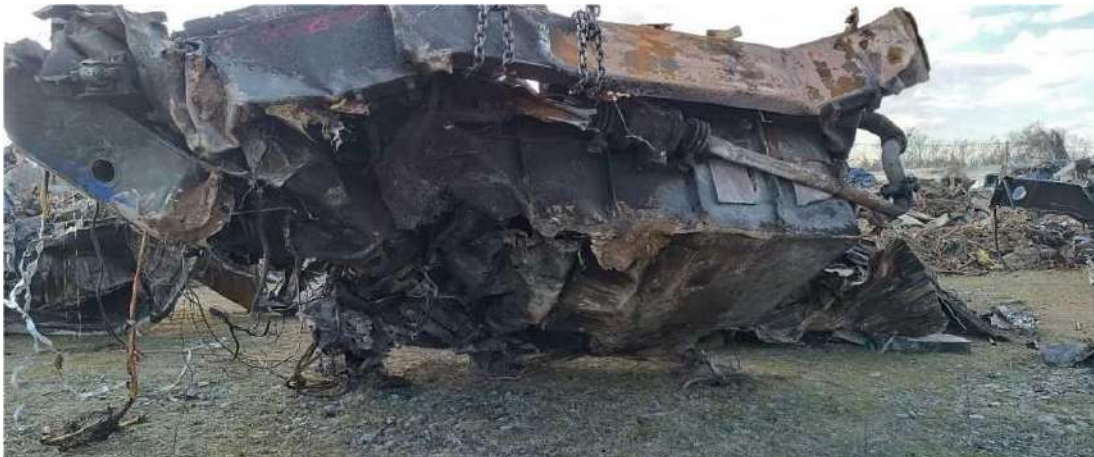
Figure 85. Position 1) 120 023 locomotive, totally destroyed, broken into large pieces. Remaining piece of the basement platform. Part with transformer still visible. Other side in Figure 17. At the position 2) the A1 1st class coach, totally destroyed, has broken into small pieces, and was not recognisable as a whole vehicle.

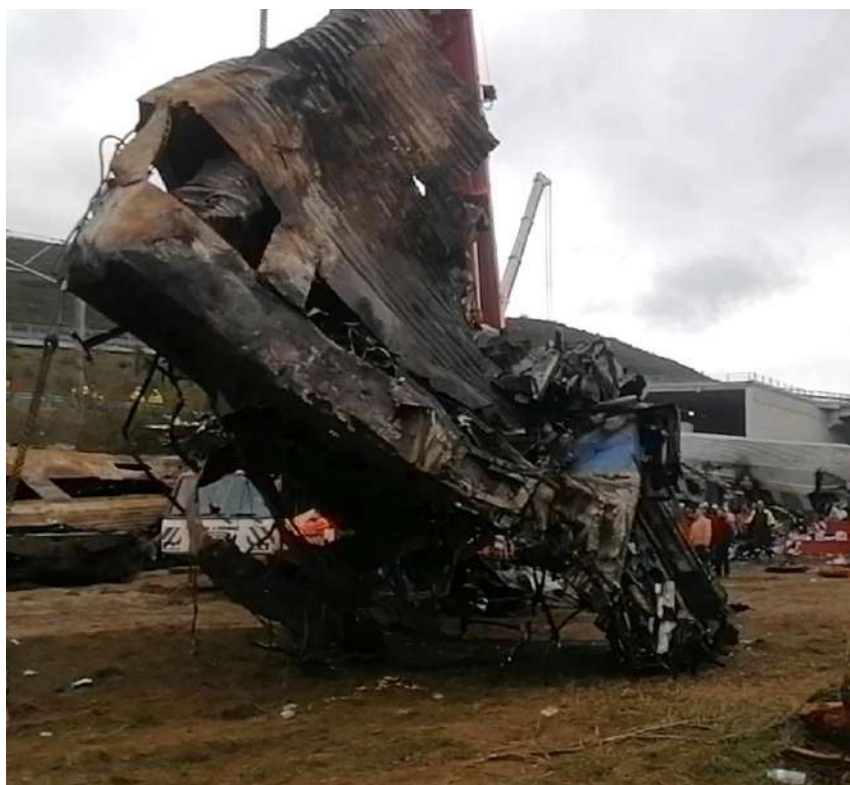
Figure 86. Position 3) Restaurant Car, very heavily damaged from initial crash (folded, bent into S-shape) and burned down. Here, suspended from the crane cables.
