Rail Accident Report

Head-on collision between a passenger train and a freight train
in Tempi, 28 February 2023

RL01-2025, 27 February 2025

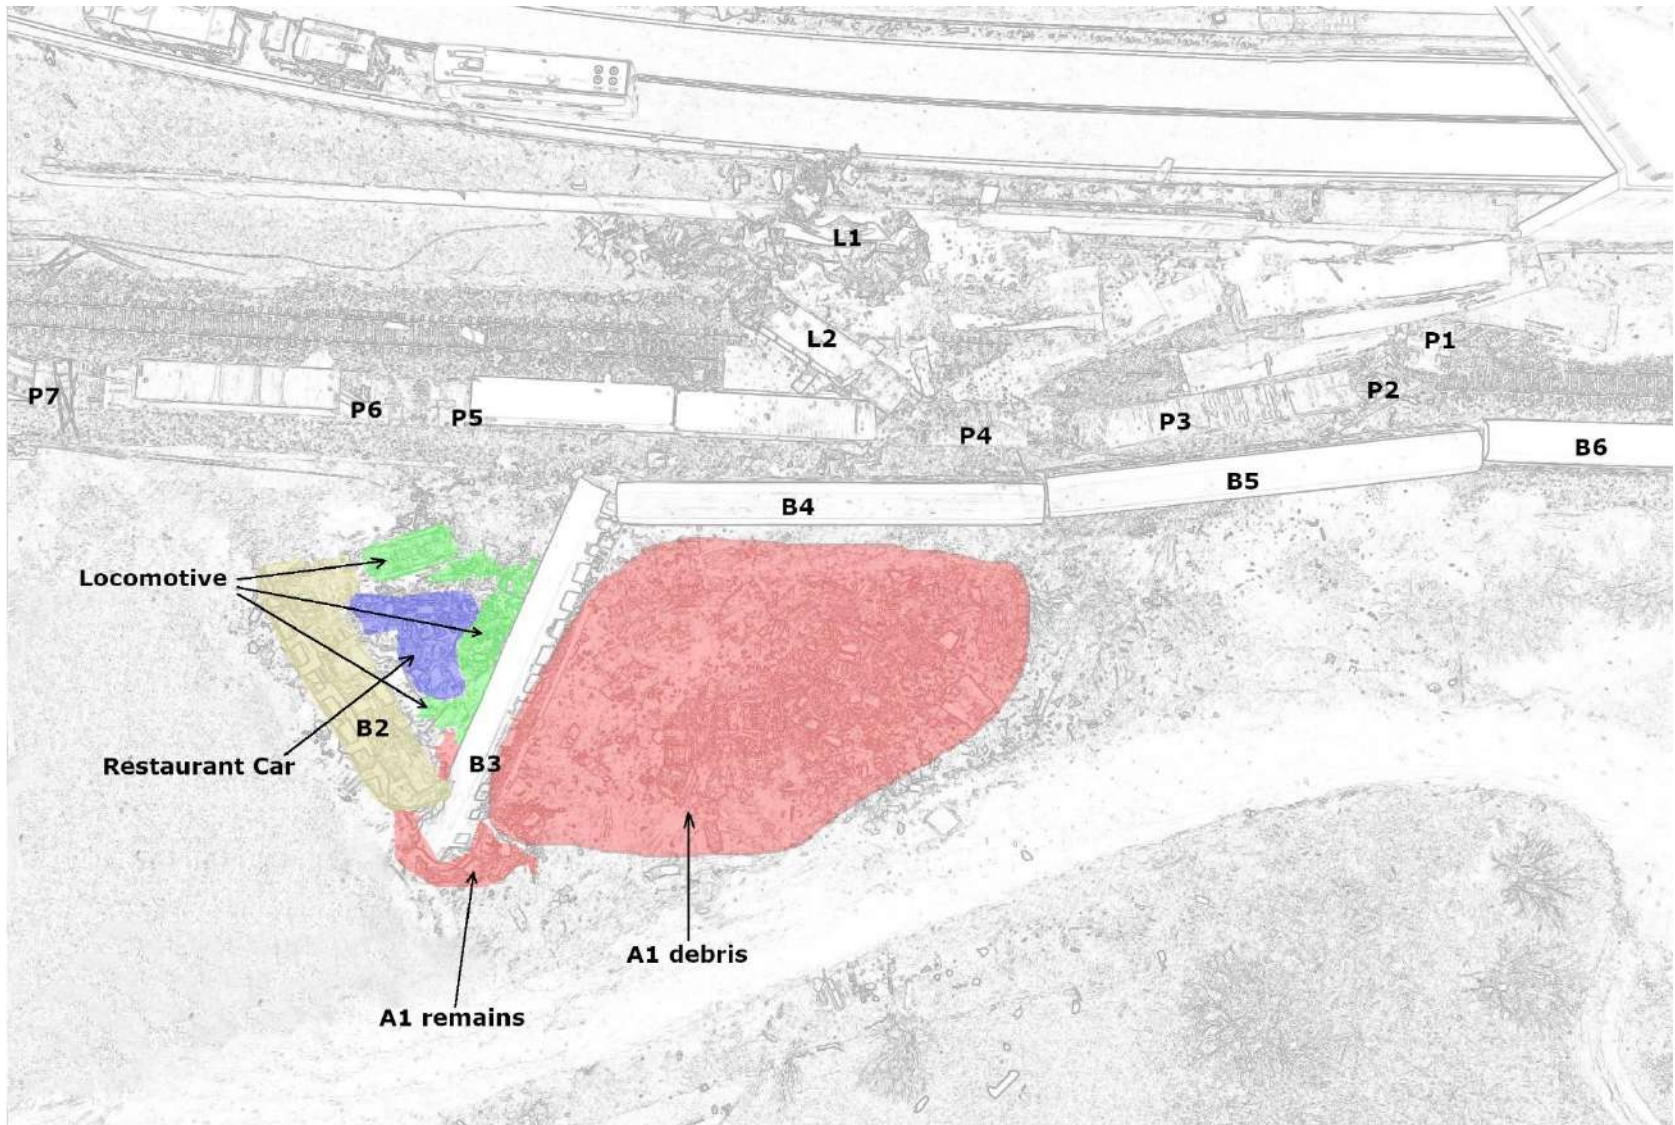
Figure 12. The accident site.

Best estimated point of the 1st collision: X, Freight locomotive 120-022: L1, and 120-012: L2, Passenger train locomotive 120-023: **Locomotive areas**, First-class A1 coach: **A1 areas**, **Restaurant Car** area, Second-class B2 on B3 head, then B3, B4, B5, B6, (B7 under the tunnel), Freight train platforms P 1-2-3-4, and freight wagons 4-7 (and other 6 not on the figure).

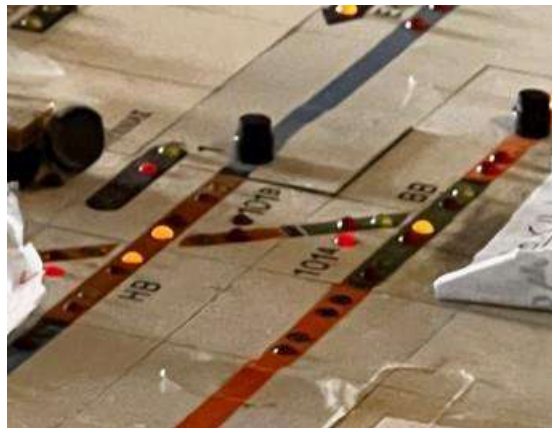
Figure 43. Switches 101A/B

- 214 Due to a problem with the overhead line that occurred earlier that day, traffic between the station of Paleofarsalo and Larissa was operated on a single line (92). This requires additional attention as well as specific communication between both station masters. Furthermore, this also requires an additional action for the trains that enter Larissa from Paleofarsalo from the descending track because the switch-combination 101 had to be turned into the bypass position to allow them onto track 2 in Larissa station (Figure 43).

- 215 Due to technical problems the switch 101A could not be operated remotely (94, Figure 43), via the control panel. To be able to maneuver the switch in the desired position, the station master has to instruct the local switch operator who in turn has to walk towards the switches and fix them in the requested position with a physical intervention. The station master in Larissa instructed the local switch operator at 22:46 to position switches 101 in a bypass position, directly after being informed by the station master of Paleofarsalo that train IC-62 had left for Larissa. At 22:57, the switch operator informed that the activity was performed.

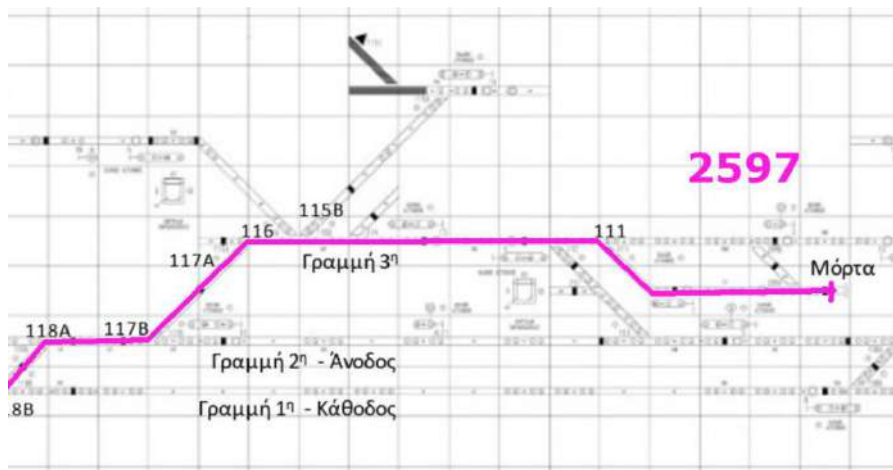
Figure 45. The route for the entry of train 2597.

- 222 Approximately around 22:35, after having received a call from the train driver of train 2597 that he was approaching the station, the station master of Larissa manually set the route with the intention for train 2597 to enter Larissa station from the north and be guided to the dead-end track between tracks 2 and 3.
- 223 This would require the setting of switches 118A/B, 117 A/B, 116, 115B and 111 to be turned in the adequate position (Figure 45). Note that this is also the action that directed switches 118 in the bypass position. Before that, these switches were turned in the straightforward position at 22:12 for the entry of train IC-63. From the recorded actions on the control panel, it can be seen that this was the last time before the departure of train IC-62 that the switches 118 were manipulated through automatic route setting.

When manually setting the route for the entry of train 2597, the station master of Larissa forgot to turn the switches 116 and 115B in the correct position. On other occasions these switches would have been in the right position after the entry and acceptance of train 2575 from Volos on track 3. Earlier in the evening, on the 28/02 this train 2575 was positioned on track 6 at 22:10 by the station master of the afternoon shift because track 3 was occupied with train 2594 that had been brought back to the station at 21:30 after traction problems arose on its way to Neoi Poroi (93).

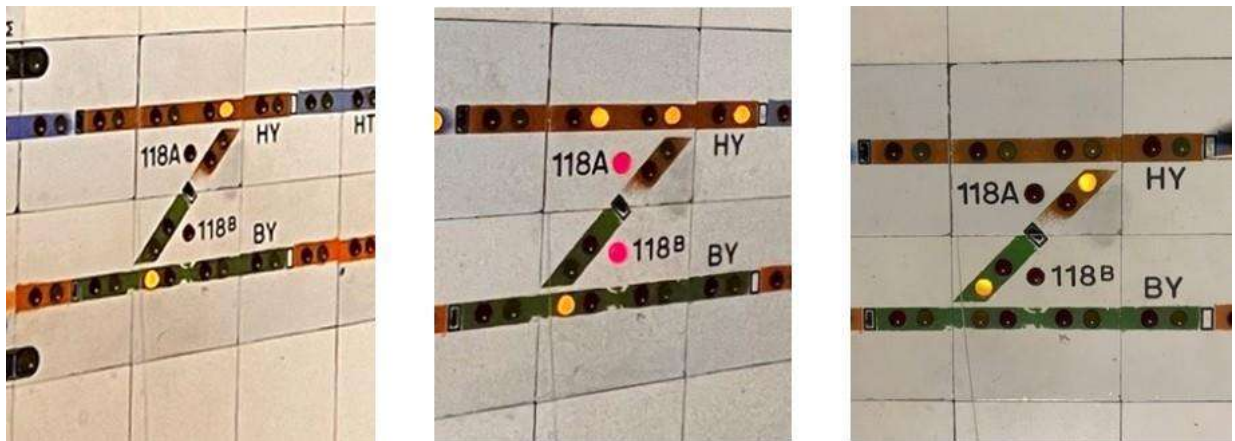
Figure 47. Detail of the switches 118 on the Larissa Control Panel (main-moving-bypass).

237 Switches are indicated on the Control Panel by the intersection of the lines showing the railway lines. Each switch is marked with a number and a letter if two switches have the same number. There are two yellow lights that indicate the position of the switch position in "main" or "bypass"(Figure 47). By setting the route, the lights in the area of the switches light up, as a combination of the light at the entrance of the switch and either the "main" or "bypass" path.

- 243 The indications on the position of switched 118 are small indications, on two distinct positions, on a larger Control Panel (the information of the Figure 47 among the ones from the whole Figure 37).

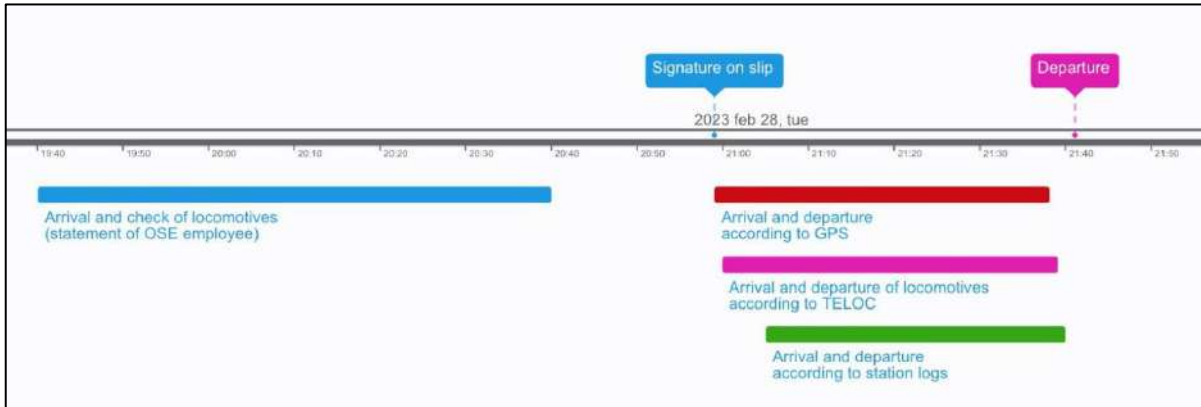
Figure 51. Timeline of the movement of the freight train 63503

284 The same timeline of events is supported by GPS data of the movement of the locomotives as provided by Hellenic Train. A similar timeline is supported also by the logbook of the station master at Thessaloniki Freight Station (locomotives arrive at 21:05, test finished by 21:35 and train leaving at 21:40).

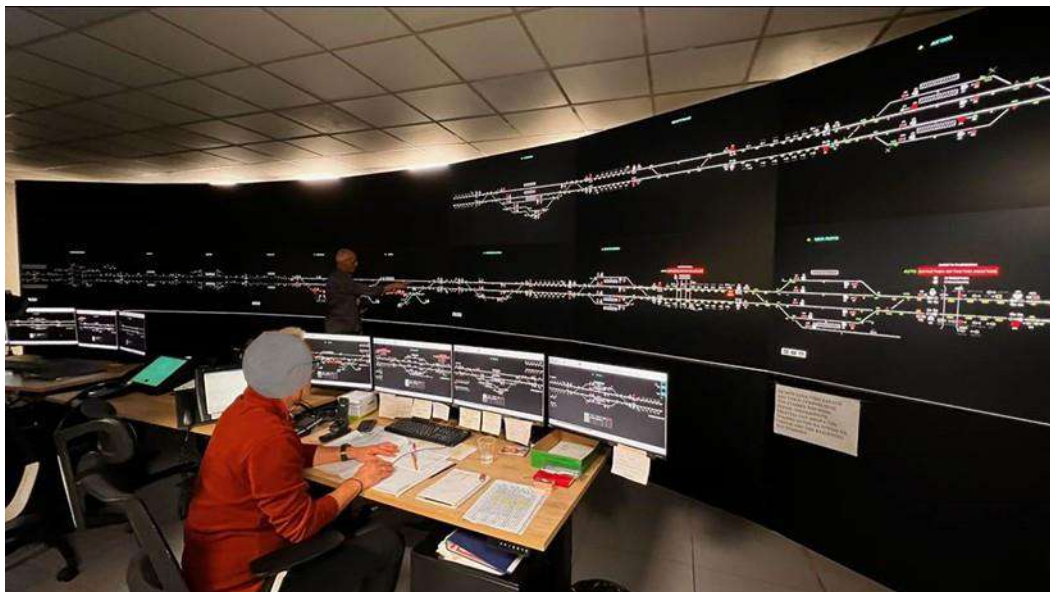
Figure 52. Digitalised traffic control room in Larissa station, with experienced staff, in 2025.

315 Another level of performance monitoring is also possible through the digitalised traffic control rooms (note that such a control room was not in place at the Tempi accident occurred), and this concerns the supervision of traffic in tunnels, and also, as in the example below, traffic management itself. As was observed during on-site visits (Figure 52), on several occasions during the investigation, it is clear that decision made via the control panel in Larissa station a few dozen meters further on (just as it could also be fifty or hundred kilometers) can easily be observed and supervised. However, it is currently not used in that way, and it is not clear if there is any intention to do so in the future. It was observed that there has been an effort to put into operation these traffic control rooms wherever infrastructure (signalling) is available. Their use, however, is still limited by lack of the maintenance of the switches. As a result, still large parts of the Athens-Thessaloniki route are not monitored remotely.

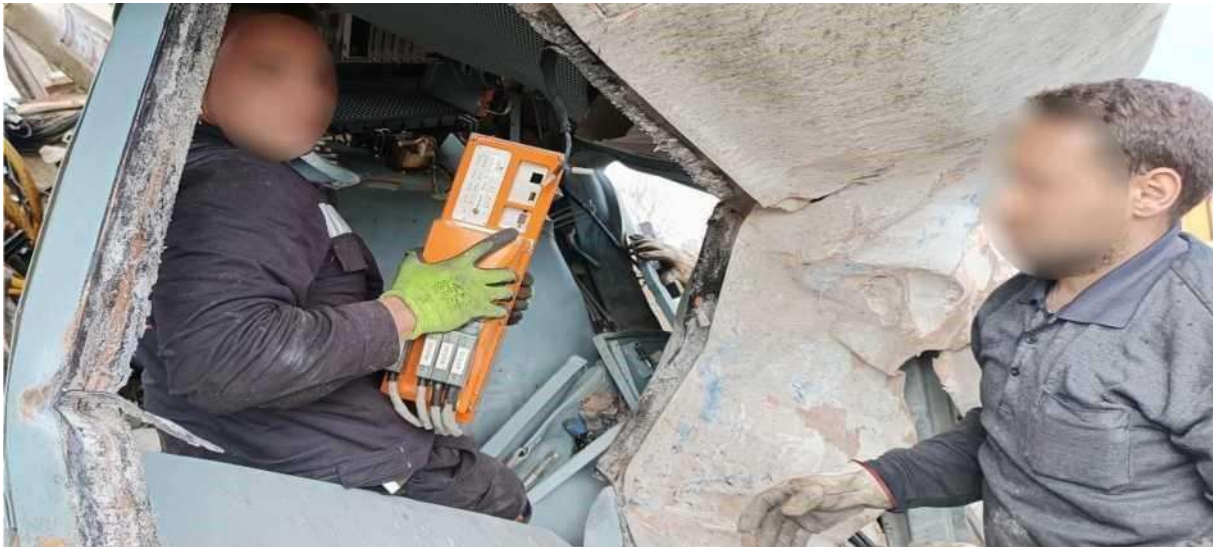
Figure 54. On board TELOC data recorder, train 63503, locomotive 120-022, retrieved by judicial experts on the 05.03.2023.

416 At the moment of the first impact, as registered by the on board TELOC data recorder that was retrieved from the accident site, the speed of train 63503 was 89.91 km/h. This is within the speed limit of 100 km/h for freight trains at this location (4.2.4). Since the train drivers of train 63503 could not possibly have identified the impending danger of the passenger train coming out of the tunnel earlier, emergency braking was activated only one second before the actual impact.

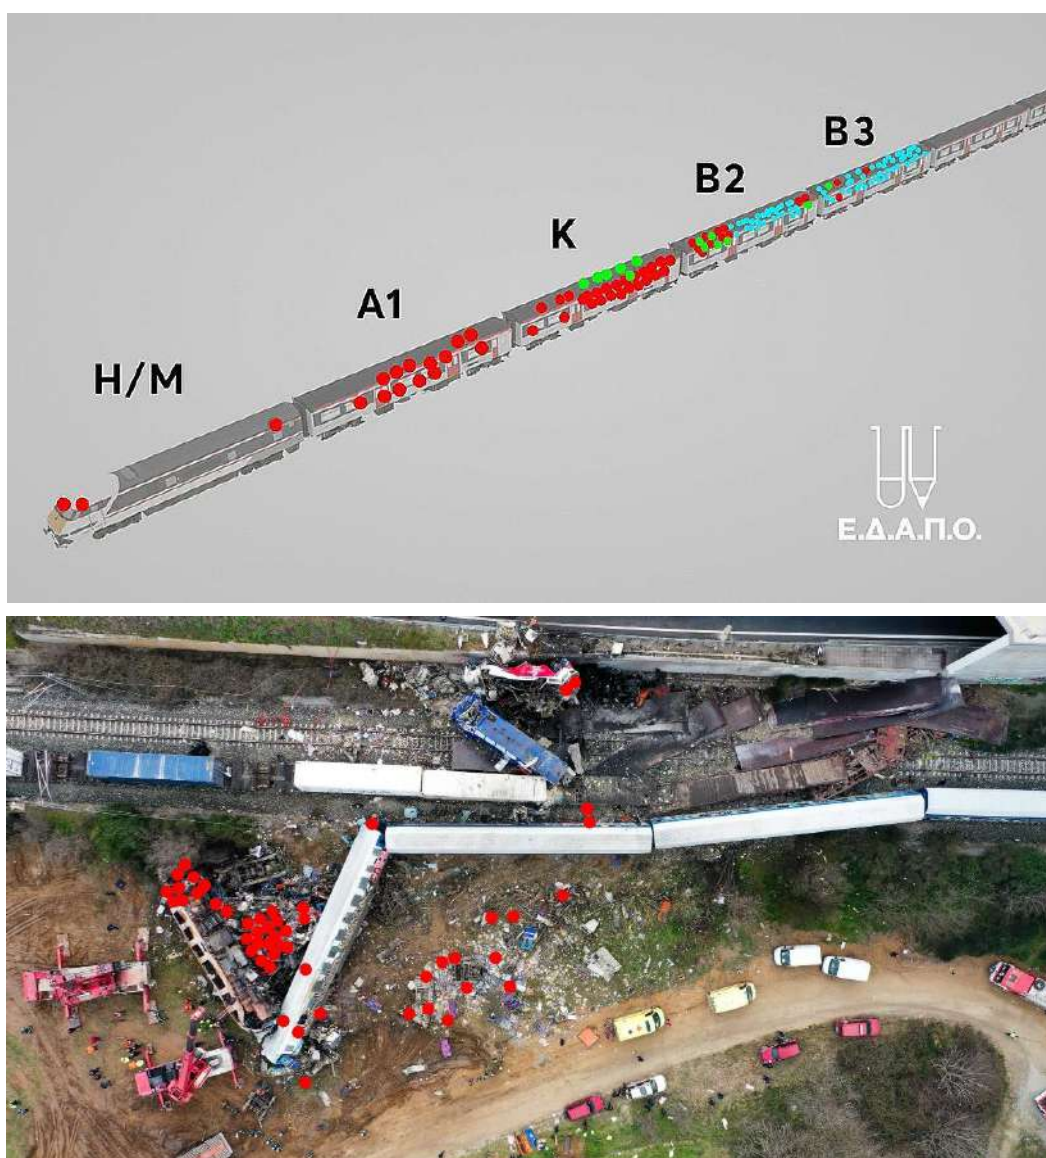
Figure 55. Initial and final estimated positions of fatalities, visualised on the scheme of the impacted part of the IC-62, and on-site.

- 423 The B3 coach of the passenger train was not subjected to heavy deceleration forces and was totally survivable, if not for secondary impacts from the B2 coach hitting its roof and a section of the locomotive hitting against the side of the B3 coach. There were 2 casualties that both suffered severe head and spinal trauma due to impact by heavy debris entering through the side windows. Both casualties were killed instantly without any chance of survival, given the unlucky position they happened to be at (other passengers sitting next to them were practically unharmed). And 5 injured victims were ejected during the crash or jumped from a height to exit the carriage.

- 445 Of the total length of the passenger train IC-62, the only parts that were totally consumed by the fire were the rear part of the Restaurant Car (letter K on the drawing, Figure 55, page 91) and the B2 passenger coach.

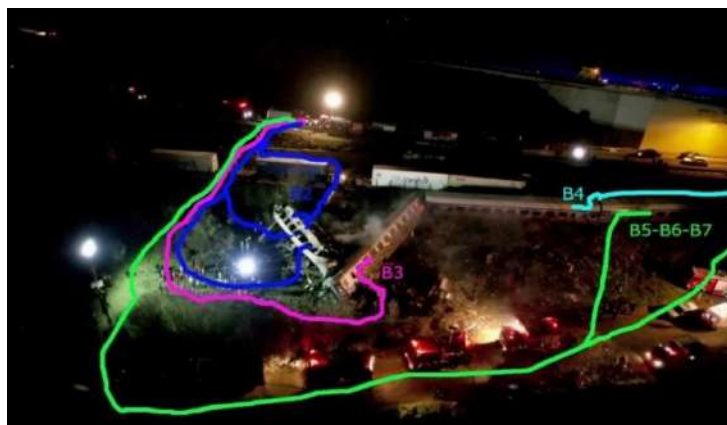
Figure 56. Self-evacuation paths of passengers before emergency services arrived at the scene.

- 427 Passengers from coaches B4 to B7 managed to operate the emergency handles of the doors and open the doors to self-evacuate successfully. On the B3 coach, access to the front doors was limited due to parts of the roof collapsing and blocking the narrow passage to the door. Passengers chose to break a window on the left side and climb down from there in order to self-evacuate. The Fire Service used the same window in order to enter and evacuate 3 casualties and 3 injured passengers who were trapped and needed mechanical tools to release them.

- 428 At least two passengers sustained serious injuries (bone fractures and dislocations) during evacuation: 1 female passenger jumped from the top row of windows of the B2 coach and was injured by falling on debris below (subsequent passengers jumping from the same window avoided this by throwing their luggage to land on top of softer surface) and 1 male passenger who was the first to jump from the B3 coach front left window, sustained serious injuries by falling on debris below (subsequent passengers evacuating from the same window took care to climb down carefully in order to avoid injury). An unknown number of passengers were reportedly lightly injured during evacuation, mostly in a similar way.
